Nuisance Flow as Failure Mechanism of Conveyance Structures  
and the Contribution of Geosynthetic Design Practice

Ian Corne, CPESC, M.Land.Arch., B.E.S.  
Application Specialist, Erosion and Sediment Control  
Nilex Civil Environmental Group

Paper prepared for presentation at the  
Fundamentals, Risk & Reliability Session

Of the 2016 conference of the  
Canadian Geotechnical Society  
Vancouver, British Columbia

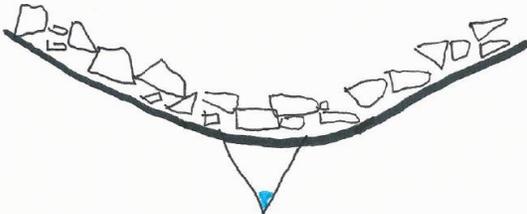
| | Continued sub-structure erosion; geotextile stretches (and becomes stronger as it stretches), rocks lock to form a bridge, and sub-structure erosion gully grows. |

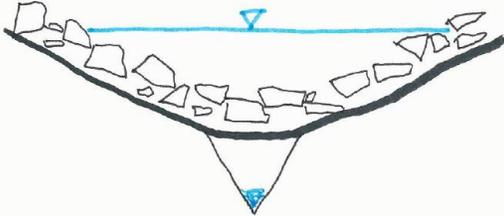
| | Storm event occurs placing extra weight of water on the geotextile. |

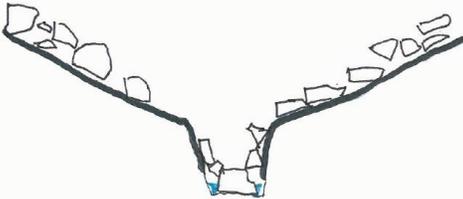
| | Geotextile and bridge-locked riprap yield under weight of storm water revealing the long-propagated erosion gully below. |

The author surmises failure is incorrectly attributed to the storm event flow when the true failure is the long-propagating erosion gully below the geotextile. The high tensile strength geotextile spans the resultant erosion gully and carries the weight of the rock above. In time, the additional weight of water running in the channel causes the geotextile to break, presenting as an apparent 'catastrophic failure' that has been long propagated.

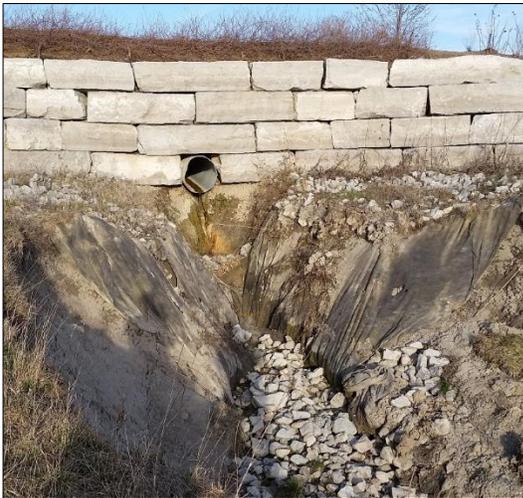
*Photo 1a. Apparent storm flow failure*

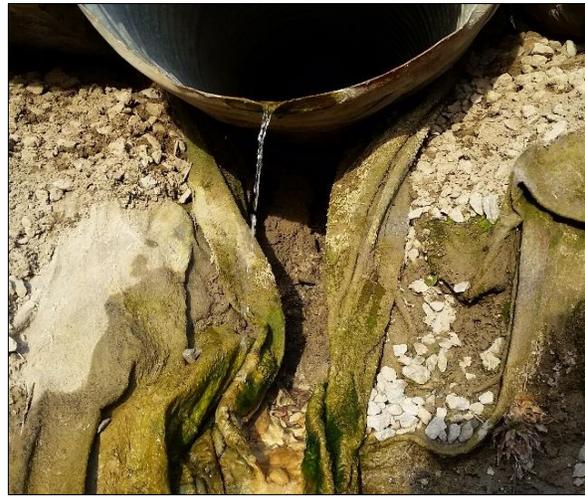
*Photo 1b. Persistent nuisance flow*

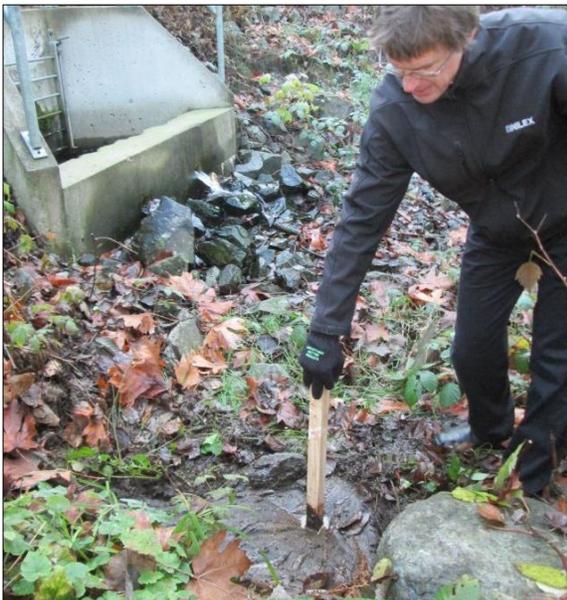
*Photo 2. Water flow below geotextile*

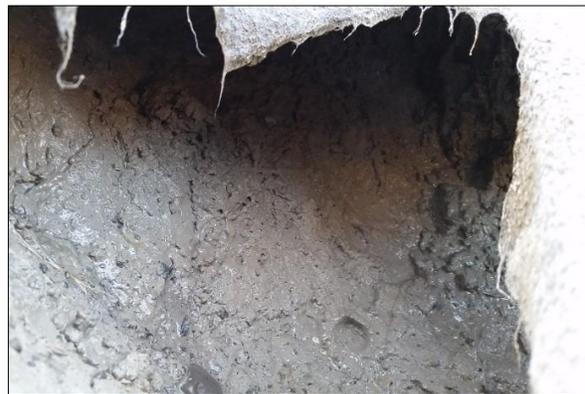
*Photo 3. Yielded geotextile over wet grade*

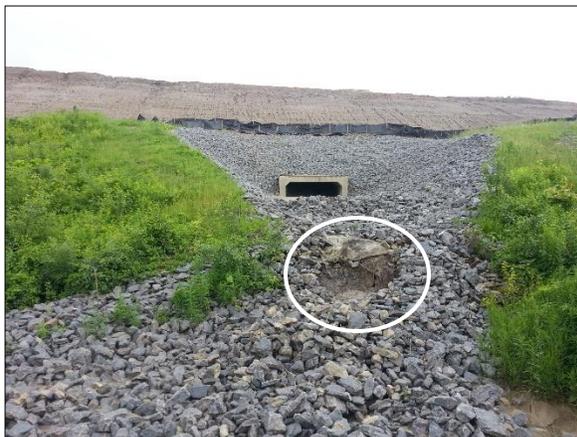
*Photo 4a. Storm flow out of a 1.5m high box culvert conveyed the riprap armour and ripped the geotextile.*

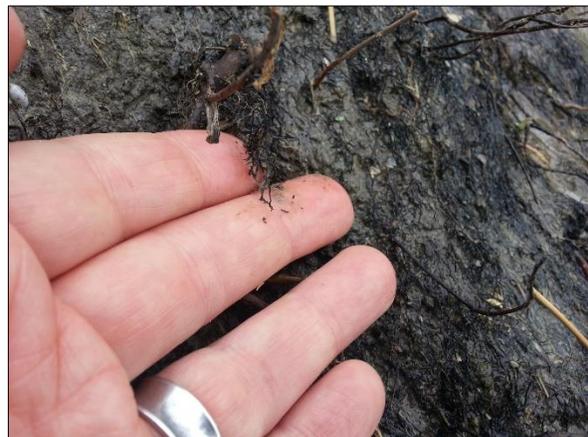
*Photo 4b. Grade remained stable because of remnant shrub rootzone left in place below the geotextile.*

Evaluation of a well-developed vegetated liner rootzone is required. A well-developed fibrous rootzone may serve to keep subgrade fines in place, thereby arresting parent material fine migration.
