GEOSYNTHETICALLY REINFORCED VEGETATION SPILLWAY ARMOURING; TWENTY YEAR CASE STUDY

Ian Corne, CPESC, M.Land.Arch., B.E.S., Abbotsford, BC, Canada

The Assiniboine River Diversion is a historic structure built in Manitoba, Canada in the early 1960s. The diversion stretches north from the Assiniboine River at Portage la Prairie to the south basin of Lake Manitoba. It diverts flood water from the Assiniboine River watershed into Lake Manitoba before flooding can reach lower elevations of the heavily populated city of Winnipeg. The diversion is one of three critical flood control structures in the province of Manitoba. The approximately 300m (985') wide structure was originally designed to carry 765m³/sec (27,000 cfs) and in 2011 received an emergent upgrade to carry 963 m³/sec (34,000 cfs).

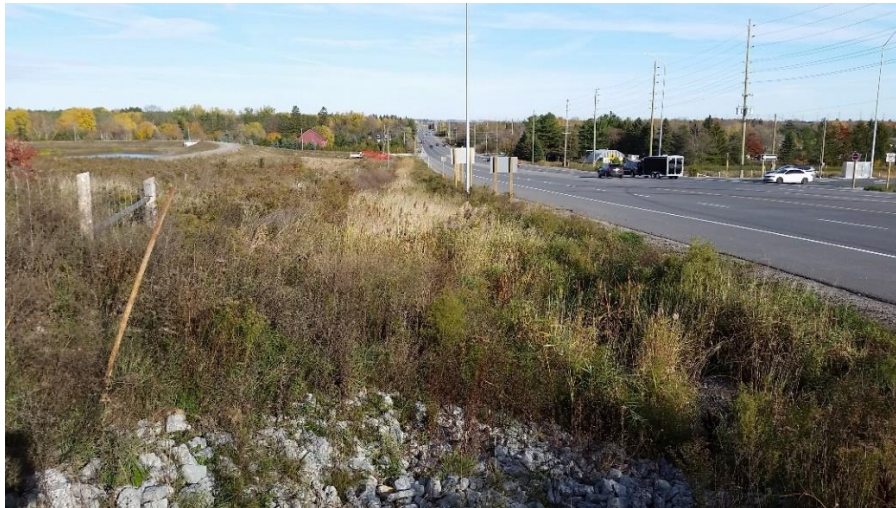
Figure 17: Stable, high performance conveyance structure utilizing TRM technology

Figure 17 illustrates a TRM structured designed for a channel that was subjected to constant flow by both nuisance groundwater wellings as well as persistent source water from offsite contribution; neither of which were properly considered in the design process. Construction proceeded with substructure erosion resulting within one week. The erosion below the TRM was repaired with a custom-fabricated biodegradable, flexible filter within which water ran until vegetation rooting ultimately caused the nuisance and persistent flows to surface.
